Uncommon fractures of Gates Glidden bur

ABSTRACT

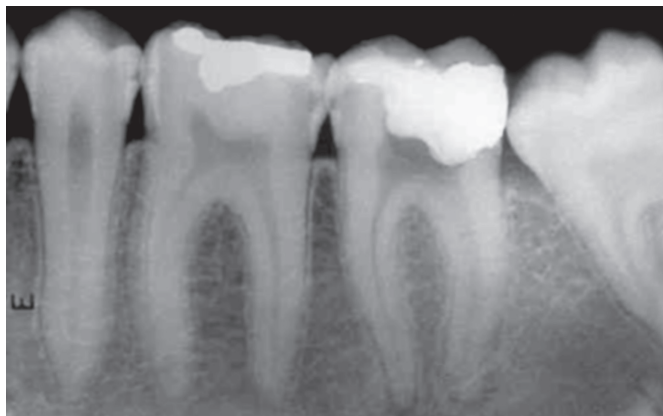
The patient of male gender, 21 years old and referred by a general practitioner to perform endodontic treatment of tooth #37. Clinical and radiographic examination (Fig 1) determined the diagnosis of pulp necrosis.

Figure 1. Initial X-ray.

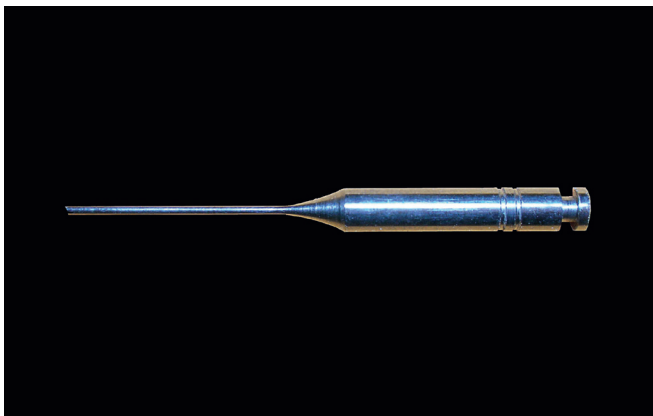
After the rubber dam, cavity access and exploitation of the root canal with a K-type hand file #10 (Maillefer, Ballaigues, Switzerland) using a #2 Gates Glidden bur (Maillefer, Ballaigues, Switzerland) in the mesial buccal canal, a slight click and a sudden change of direction were perceived. By removing the bur from the root canal, its tip break was observed (Fig 2). A radiographic evaluation showed the fractured bur tip retained in the canal middle third (Fig 3).

Figure 2. Fractured Gates Glidden bur.

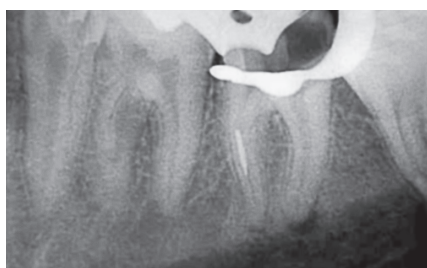
Figure 3. Fractured bur tip, retained in the canal middle third.

occurrence of instruments fracture, it is always necessary to respect the instruments' kinematics of use, avoiding sudden movements inside root canal. The instrument fracture caused by fatigue presents high occurrence rates and could be avoided by professionals.^{4,8} In this case, it was evidenced that the fracture resulted from fatigue and torsion of the instrument, as noted in the scanning electron microscopy (Fig 7). It should be also noted that there was no previous preparation of the cervical third, which became another stressing factor on the bur, as seen in Figure 3.

Initially, we tried to remove the bur tip with a K type file #10 followed by Headstroem files, but without success. Using a #10 K file it was possible to pass by the fragment. Then, we decided by using a CV-Dent 1000 (CVD Vale, São José dos Campos, Brazil) ultrasound, with the T0S-E1 tip, indicated for removal of fractured instruments. Before using them, an anti-wear curve was developed with a LA Axxess #35 (SybronEndo, Orange, CA, USA) bur, improving the access to mesiobuccal canal. The ultrasound power was set at 50%, at endodontics function, working around the bur tip for a few minutes. Developing a radiographic confirmation of the working length, it was possible observe the fragment removal (Fig 4).

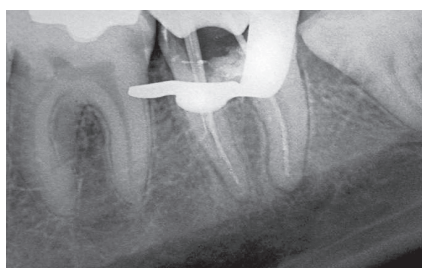
Figure 4. Working length.

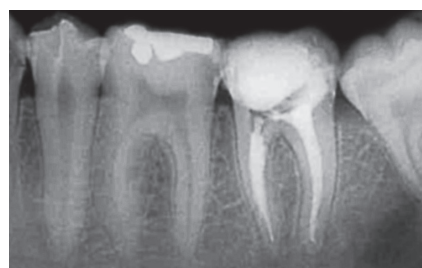
Figure 5. Root canal obturation.

The root canal obturation was performed with Sealer 26® (Dentsply, Petrópolis-RJ, Brazil) and gutta percha cones by Tagger hybrid technique (Fig 5). The X-ray control was performed after one year (Fig 6).

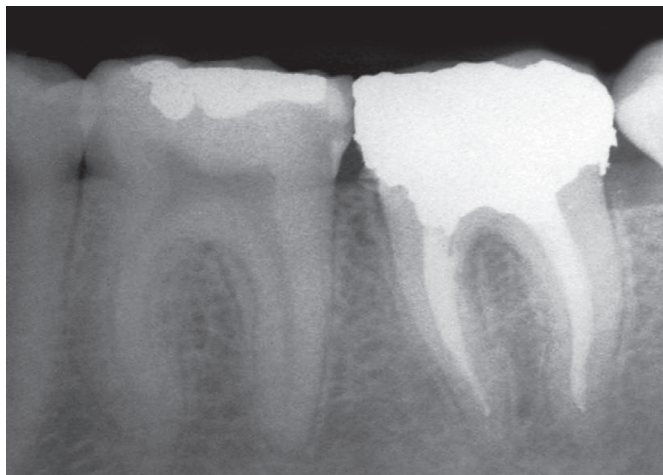
Figure 6. Control X-ray after 1 year.

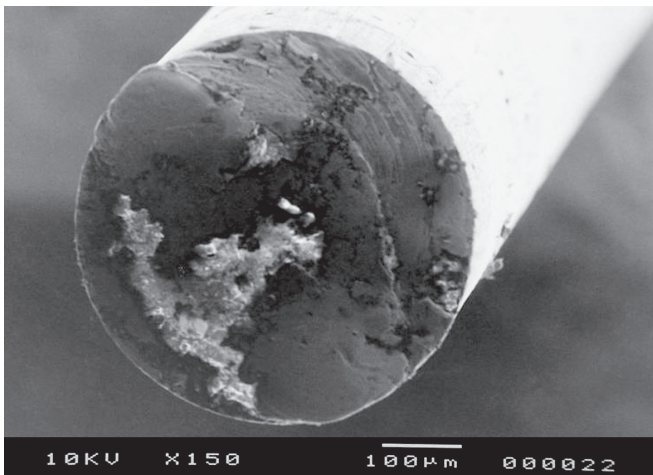
Scanning electron microscopy with an increase of 150X was performed on the fractured bur (Fig 7).

Figure 7. Scanning electron microscopy (150x).
