Planning and diagnosis predictability by means of cone beam CT before endodontic treatment: clinical resolution

ABSTRACT

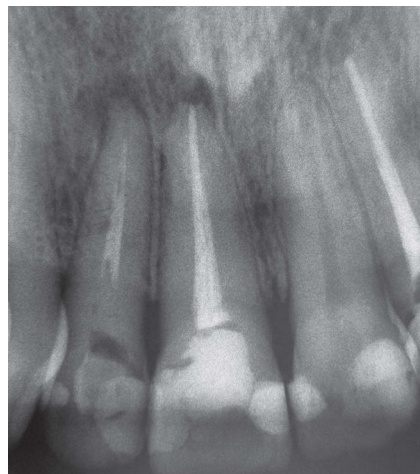
Figure 1. Initial radiograph.

A 35-year-old male patient attended the Endodontic Clinic of the Army General Hospital of São Paulo (HGESP), complaining about severe pain in the buccal region of tooth #22. The patient reported a history of endodontic retreatment of tooth #22, with the last intervention being performed four months before. At clinical examination, the patient reported pain on palpation and vertical percussion of tooth #21 and 22. The examination also revealed the presence of edema in the buccal region and tooth mobility level I in #22, absence of periodontal pockets at probing and negative response to pulp vitality tests of teeth #21 and 22. The diagnostic radiograph showed a circumscribed radiolucent apical image that suggested a periapical lesion. In spite of that, a radiopaque image, compatible with root filling material, was observed in the middle and apical thirds of the canal (Fig 1). The patient was not subject to unnecessary diagnostic procedures.

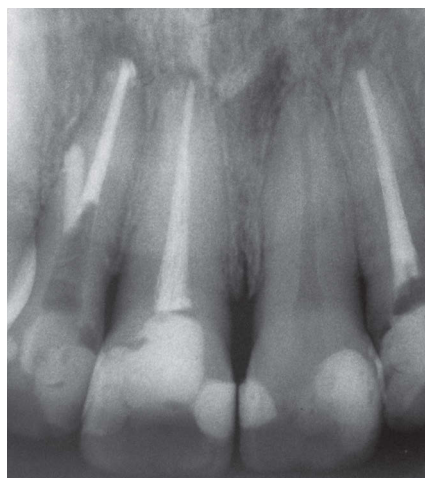
Figure 5. Obturation of the apical third and perforation sealing with MTA.

Filling was performed with gutta-percha and AH PLUS sealer (Dentsply/Maillefer) by means of the continuous wave condensation technique. Obturation was performed from the apical third to the level of root perforation so as to allow sealing with MTA

(Angelus, Londrina/PR Brazil) (Fig 5) and intracanal anchorage with fiber glass post. In this case, an esthetic fiber glass post (Reforpost/Angelus) was selected. The middle and cervical thirds were conditioned with 37% phosphoric acid gel, and one-bottle adhesive system (Single Bond®) was applied. The post was cemented with resin cement (Rely X® - 3M). Afterwards, the fiber glass post was coated, and coronary filling was carried out with light-cured resin Z100 (3M Brazil). At treatment completion, radiographic images were retaken, revealing correct crown shielding (Fig 6).
